How to simply identify a damp house

A HOME OWNER'S GUIDE

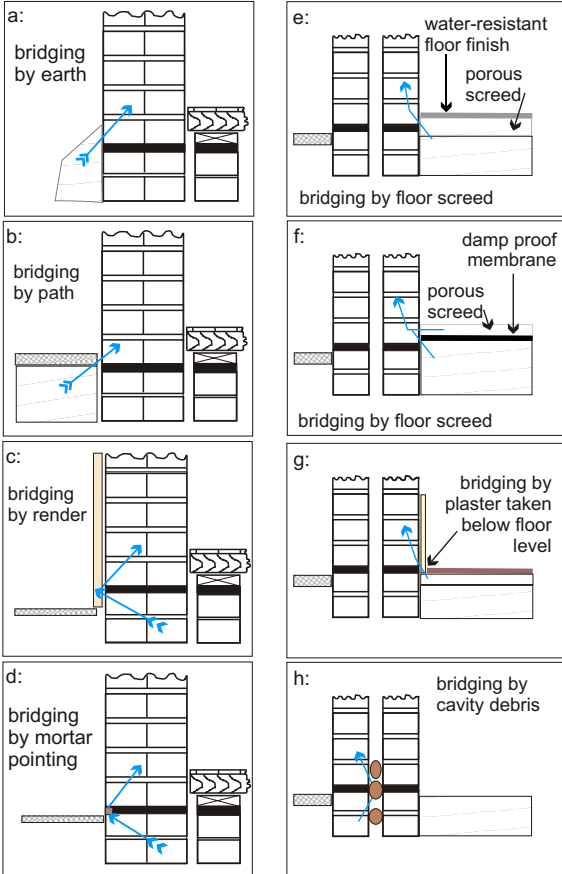
Figure 2.: Bridging of damp courses

In the higher value buildings large bluestone pitchers were used as footings and the damp could only come up the mortar lines. However, in poorer buildings bluestone rubble was used with a large amount of lime mortar between the bluestone in the walls allowing the damp to rise easily. Once the damp reaches the hand made bricks, rising damp is firmly established. A build up of the earth level against the bluestone pitcher footings, either inside or outside the house, encourages the rise of the damp in the final mortar lines to the bricks. If the bluestone and the damp course are bridged then rising damp is the sure result. Bridging can also occur by render covering the damp course. (See Figure 2.)

Concrete, either inside or outside the building, may cause problems due to the bridging of the damp course by the fill under the concrete. In addition, in damp locations, the earth under the concrete can become very wet and cause rising damp in the walls where the old damp course in the walls is not sufficiently effective to stop it.
