**TECH-DRY BUILDING PROTECTION SYSTEMS PTY. LTD.**  
ACN 005 307 684 ABN 62 922 836 289  
177-179 Coventry Street,  
South Melbourne, Victoria 3205, Australia  
Telephone: 61 3 9699 8202 (all hours)  
Facsimile: 61 3 9696 3362  
Website: [www.techdry.com.au](http://www.techdry.com.au)  
E-mail: [info@techdry.com.au](mailto:info@techdry.com.au)

# **HOW TO SIMPLY IDENTIFY A DAMP HOUSE**

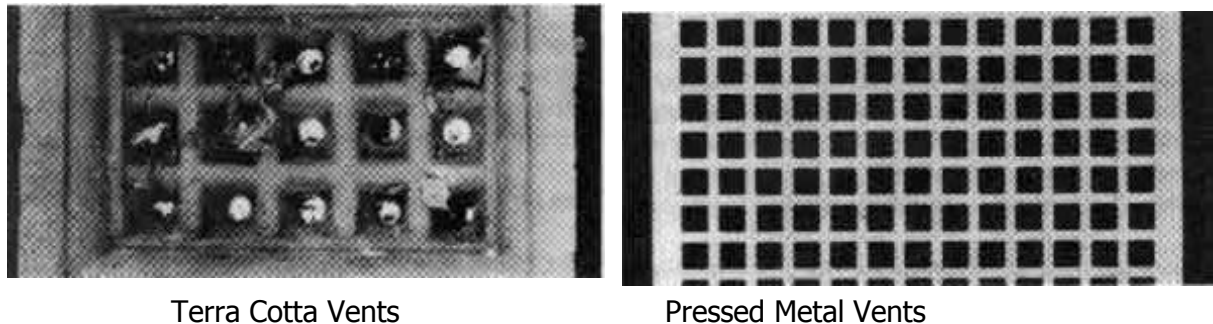
**Figure 1.**

ventilation in the past, then the timber floors and stumps could be in poor condition. Terra cotta vents as in Edwardian houses are very poor ventilators and are part of the cause of floor problems in such buildings. (See Figure 1)

Terra Cotta Vents

Pressed Metal Vents

In wet soil conditions the building needs one double ventilator for every 1.5 m of wall length around the entire building perimeter.

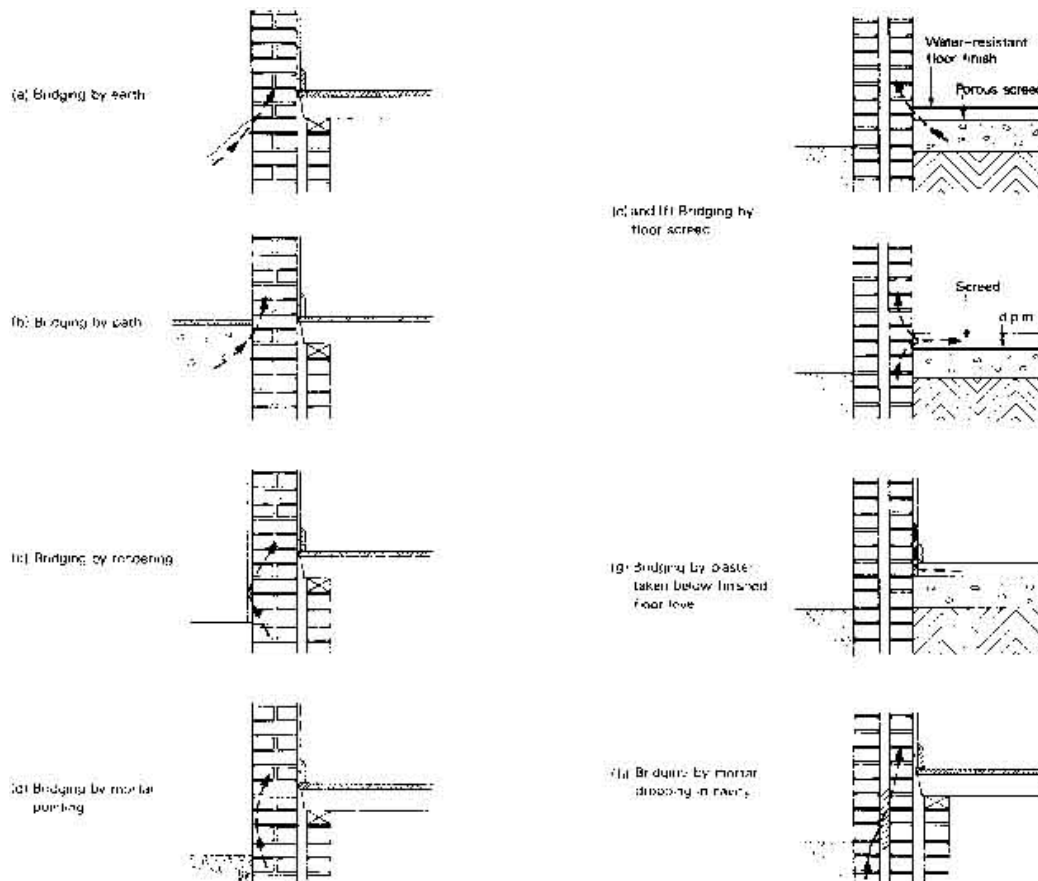
**Figure 2: Bridging of damp -proof courses**

If the bluestone and damp course is bridged then rising damp is the sure result. Bridging could also occur by rendering covering the damp course. (See Figure 2.)

In Victorian building the theory of preventing rising damp was that blue-stone which is impermeable to water was used as the footings and a damp course (eg., coal tar, bitumen and sand, or slate) was incorporated in the mortar line directly above it. In the higher value buildings large bluestone pitchers were used as footings and the damp could only come up the mortar lines. However, in poorer buildings bluestone rubble was used and such a large amount of lime mortar was used between the bluestone in the walls that the damp had an easy rise. Once the damp reaches the hand made bricks then rising damp is firmly established. Where the earth level has been raised against bluestone pitcher footings to near the bricks either inside or outside the house, this encourages the rise of the damp in the final mortar lines to the bricks.

Concrete present either inside or outside the building may cause problems due to bridging of the damp course by the fill under the concrete. In addition in damp locations the earth under the concrete can become very damp and cause rising damp in the walls where the old damp course in the walls is not sufficiently effective to stop it.
